REPORT
CONTAINER STORAGE AREA
BUILDINGS 17 AND 39
FOR
HILLMAN PROPERTIES NORTHWEST, INC.
VANCOUVER, WASHINGTON

DECEMBER 29, 1988
JOB NO. 17809-001-005

Container Storage Area
Buildings 17 and 39
2000 East Columbia Way
Vancouver, Washington
Job Number: 17809-001

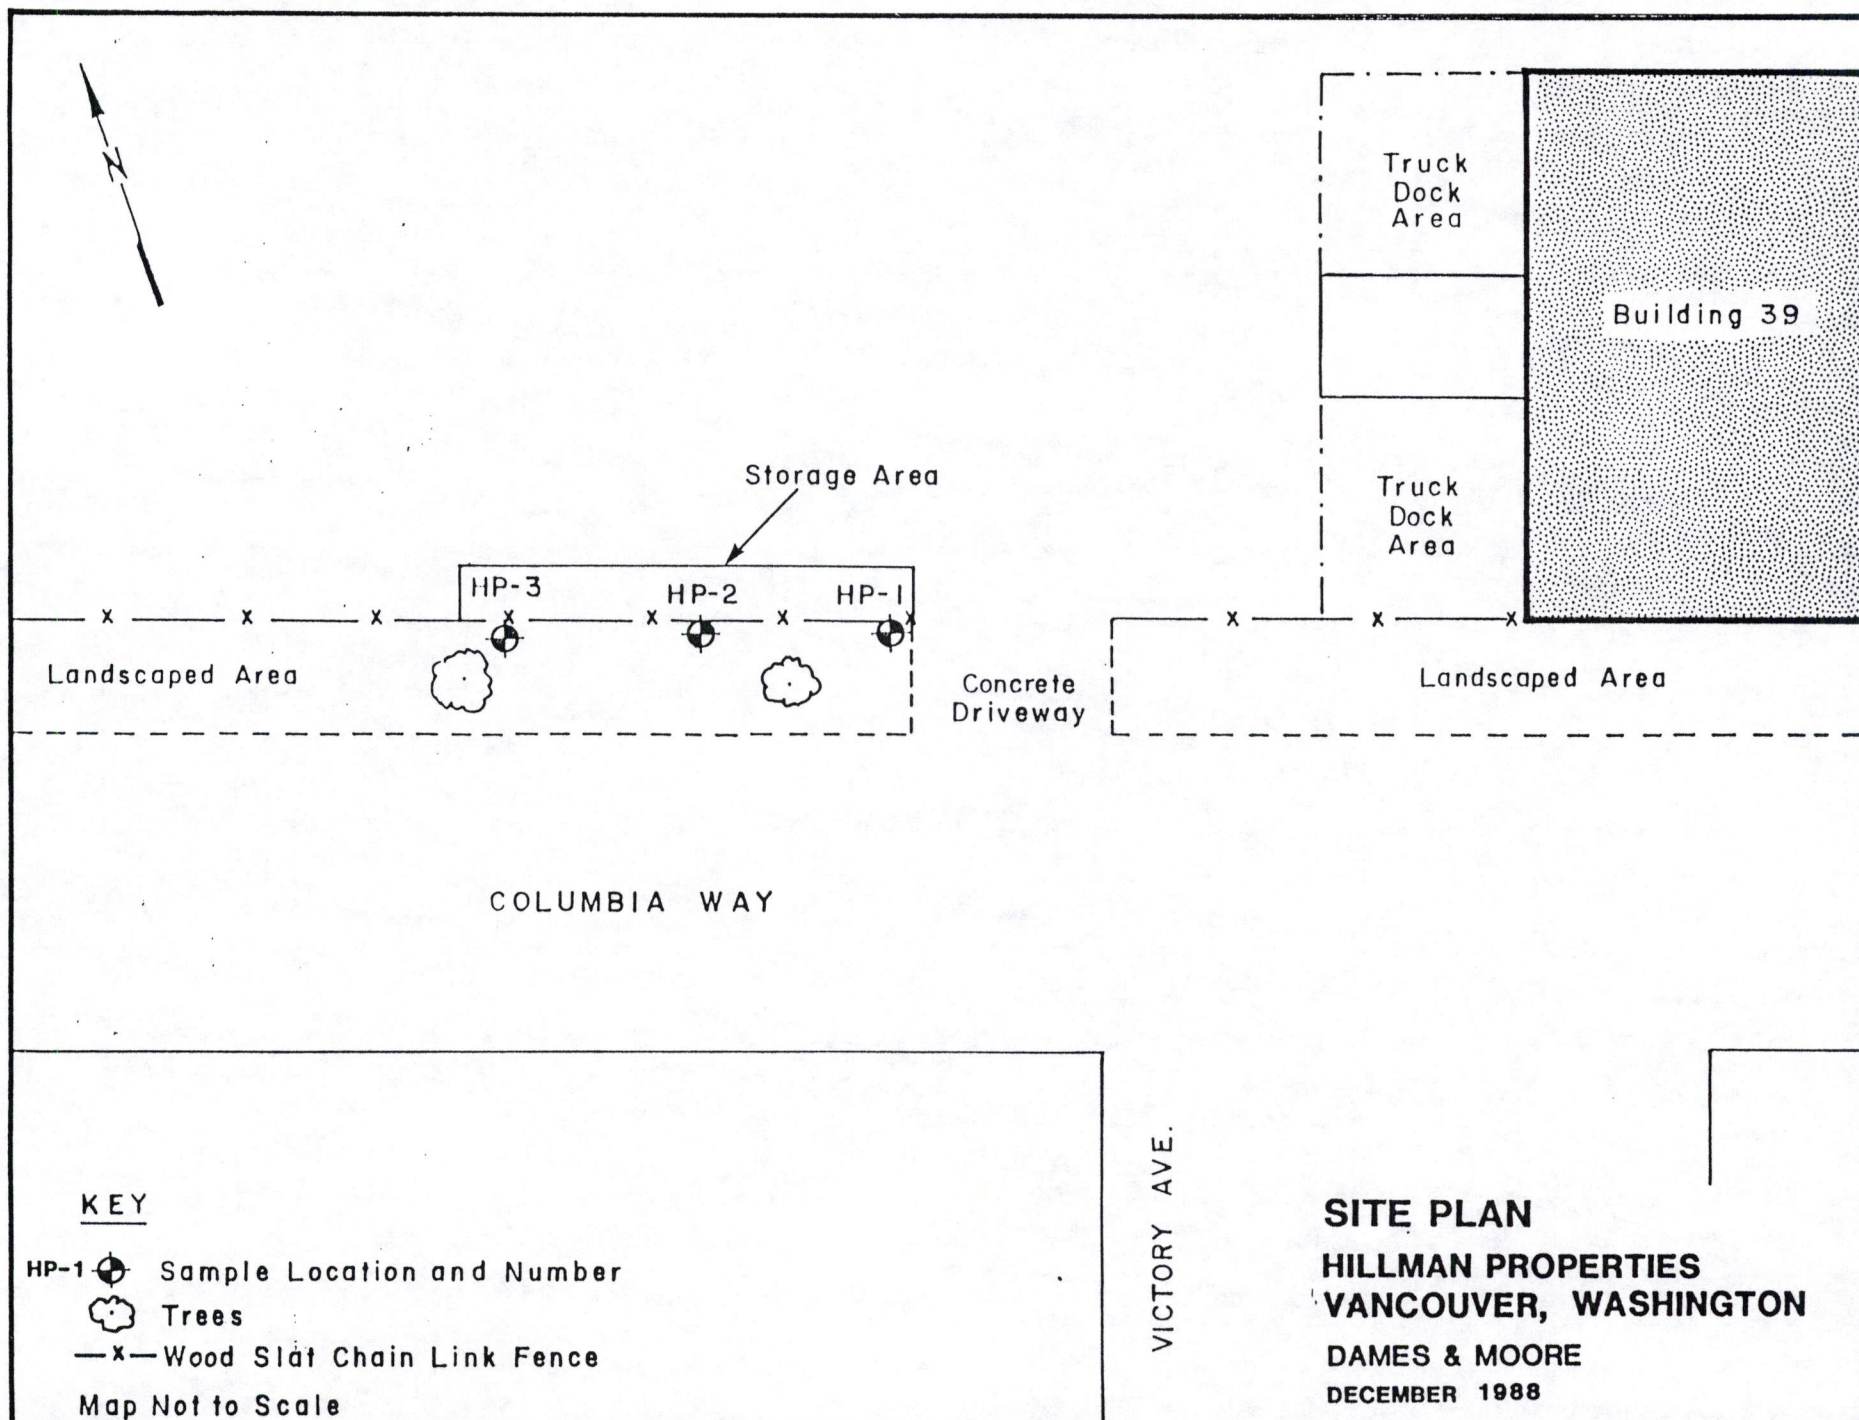
Three surface soil samples were collected from a landscaped area adjacent to the storage area (Figure 1). Holes were dug with a stainless steel spoon to a depth of one foot below the surface (exclusive of cover material). The sampled material was compacted sand. For each sample, material was removed from the side of the hole, composited on a clean plastic sheet, and placed directly in clean glass sample jars with Teflon lids. Sampling implements were washed with a solution of Alconox and water and rinsed with deionized water prior to collecting each sample. Samples were transferred to the laboratory under fully executed chain-of-custody documentation and analyzed for total lead. Sampling activities were documented by field notes made at the time of sampling.
